# **Field Report for Airborne Data Collected In Support of US EPA Region VI South 4 Group Fire 30 November 2019 Flight 7**

## **Flight 7 -- 30 November 2019**

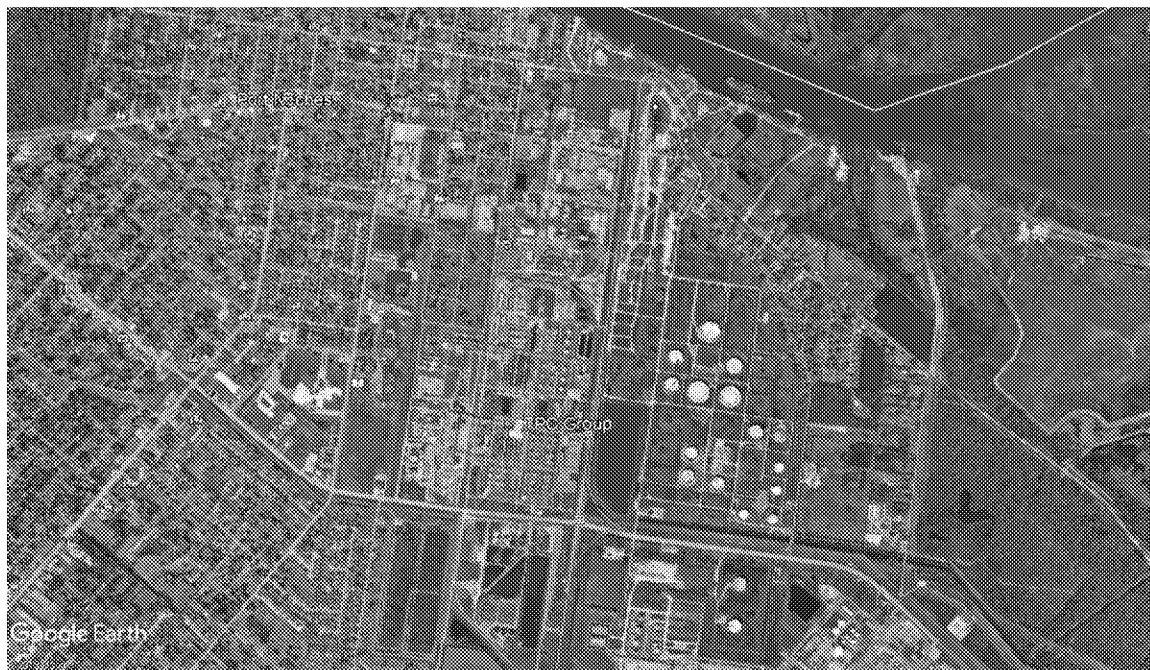
Figure 1: South 4 Group Facility, Port Neches, TX

On 27 November 2019 an explosion and subsequent fire was reported at the South 4 Group facility located near Port Neches, TX. Local information indicated that at approximately 0100 (central) a large explosion rocked the area. The explosion subsequently caused a massive fire at the facility in a short amount of time. Local official ordered a 4-mile evacuation order which as of 0800 on 27 November 2019 was still in effect. Reported onsite products include various olefins, butadiene, and isobutylene. The geographical coordinates of the facility are 29.9222N, 95.0547W (figure 1).

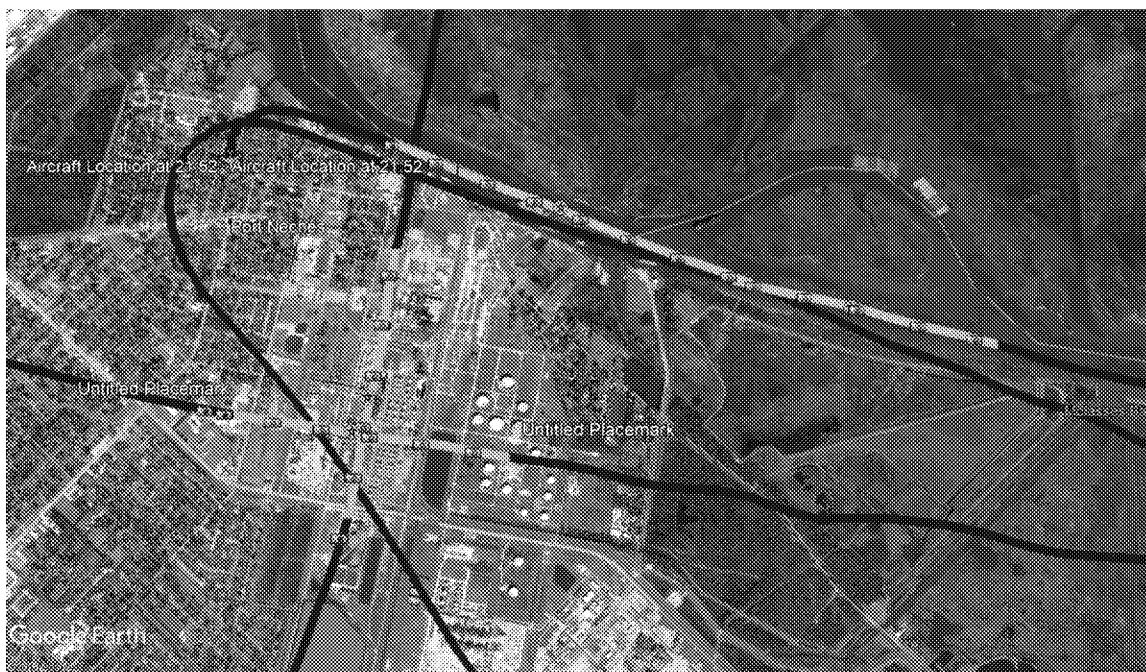
Figure 2: Data collection passes, South 4 Group Fire, Port Neches, TX. The blue lines represent the ASPECT flight path, green lines represent when the FTIR was actively collecting data, the yellow icons with star is the centroid of the line scanner image, and the camera icons represent when a photo was taken.

The aircraft was airborne at 1455 (central) was over the site at 1525 (central). A total of 2 test and 4 data collection passes were completed before IFR conditions forced a termination of the data collection due to low ceiling. Flight information is summarized in Appendix A and Figure 2.

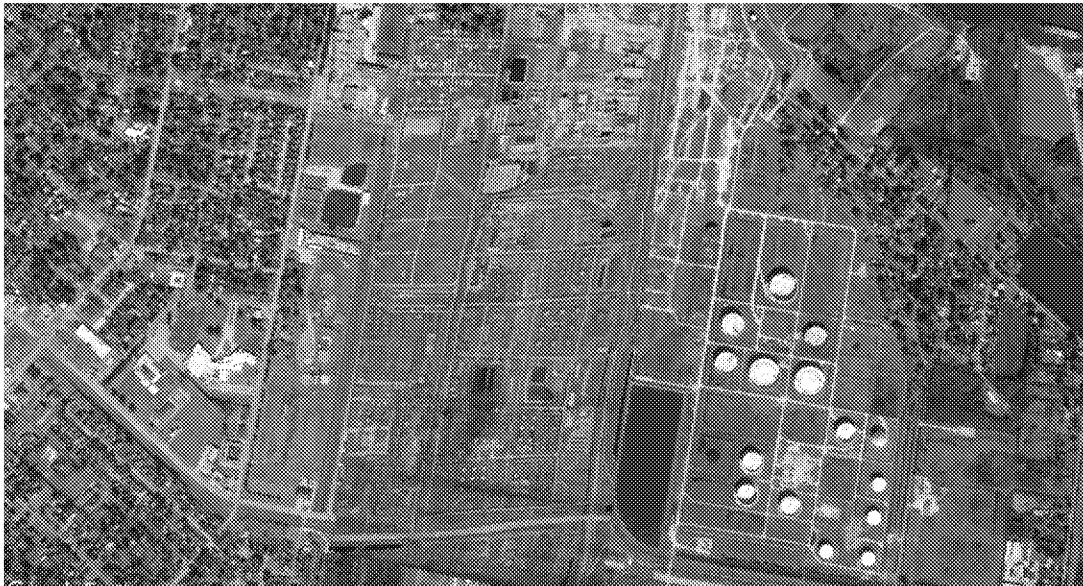
A total of 2 test and 4 data collection passes were made in the proximity of the fire and an infrared line scanner image was generated for each pass. Figure 3 shows a typical 3-band infrared image obtained from data collected for Run 8. This image is somewhat distorted due to an extreme crosswind at the flight altitude. Analysis of the image generally shows minimal elevated thermal sources with a cooler signature leaving the site; most likely water spray from the water cannon. No chemical plume can be seen being emitted from the site. Figure 4 was generated by flying the system over the Neches river in an effort to image any oil sheen in the waterway. No sheen was observed. It should be noted that the image features on the east side of the image are clouds below the aircraft.

Figure 3: -- 3 band IR image, Flight 7, Run 4, South 4 Group Fire

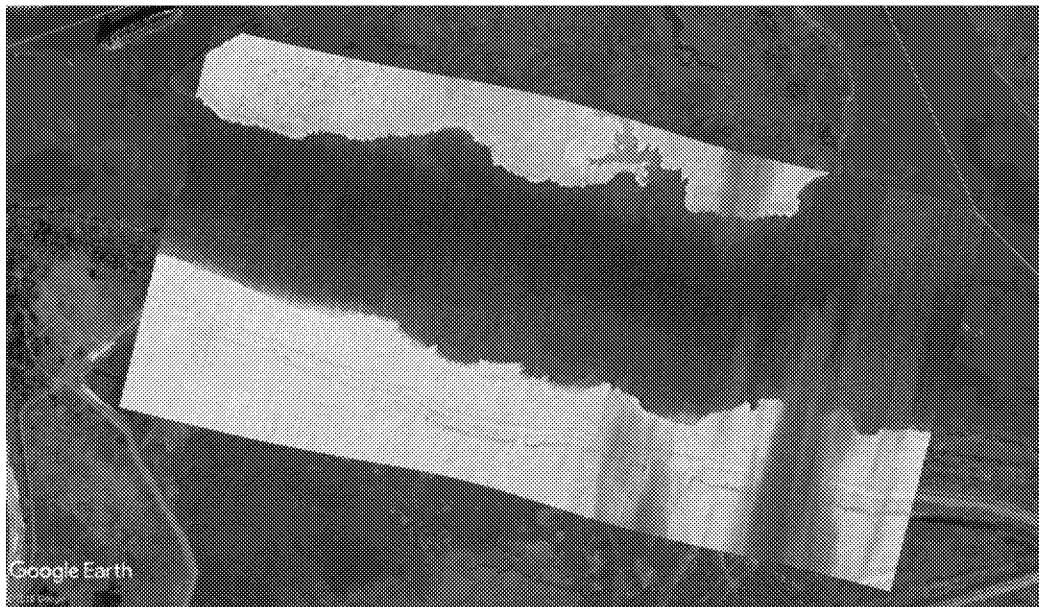
Figure 4: -- 3 band IR image, Flight 7, Run 5, South 4 Group Fire

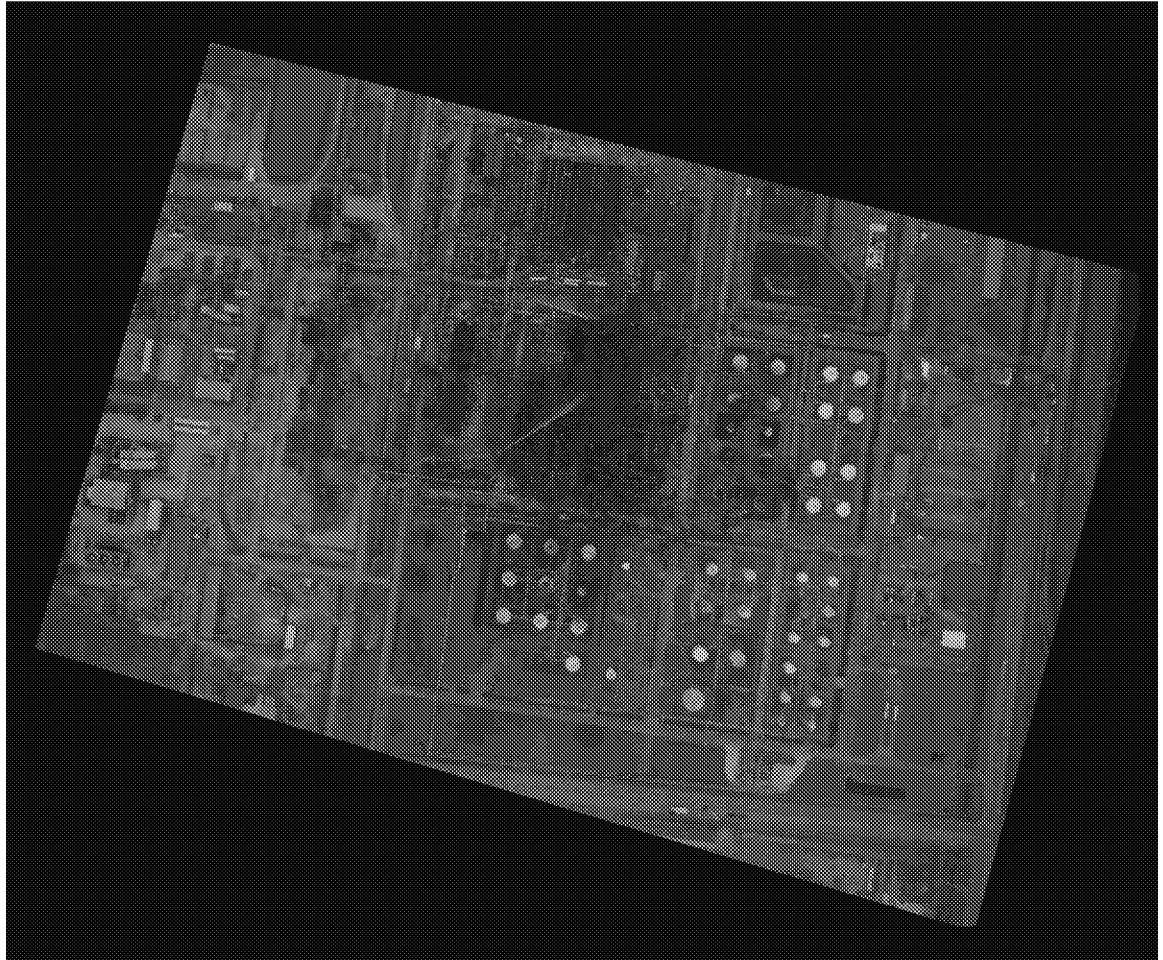
A full set of high resolution aerial digital photography were collected as part of the flight. Figure 5 shows a representative image collected as part of each pass. Due to the time of day and cloud cover the image is dark. As with flight 6, the image shows that little if any smoke is being emitted from the site. At the time of collection, only one water cannon was in operation. Oblique image collection was not possible due to the onset of IFR (low ceiling) conditions.

Figure 5: Aerial Image of the South 4Group Fire
